NASA TN D-7992

APOLLO EXPERIENCE REPORT - GUIDANCE AND CONTROL SYSTEMS: MISSION CONTROL PROGRAMER FOR UNMANNED MISSIONS AS-202, AFOLLO 4, AND APOLLO 6

Gene F. Holloway

Lyndon B. Johnson Space Center

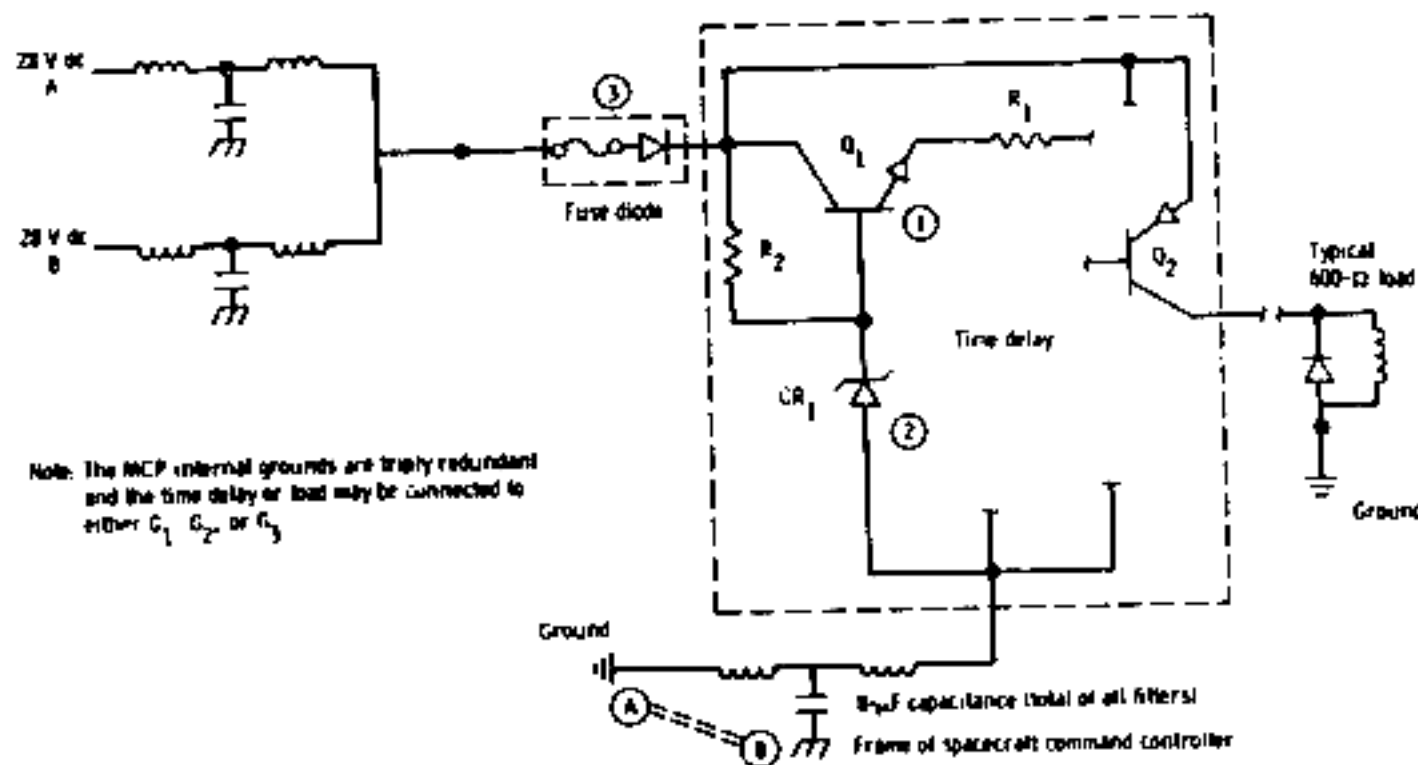
Figure 17. - Time-delay circuit schematic.

For a 14-month period ending in April 1967, NASA and various aerospace industry representatives combined their efforts to resolve the MCP time-delay and fuse-diode failures. The failure mode was readily established shortly after the first time-delay circuit failed. Transistor Q_1 (fig. 17) of the time-delay circuit shorted (collector to base) causing zener diode CR_1 to overload, exceed the thermal rating, and fail, so that

the fuse diode on the time-delay input was overloaded and failed (open circuit). Numerous attempts were made to establish the cause of the failure. The following list of significant events in the investigation indicates the amount of study on this problem.

The extensive engineering investigation to resolve the time-delay failures revealed that this failure, as well as several others, resulted from the transients caused by the 500-V dc megohm portion of the unit-level test at the vendor's facility. Failure of 8 diodes, 4 capacitors, 22 fuse diodes, and 14 time delays could be attributed directly to these transients. The listed failures were of an induced nature. During factory test, components were stressed beyond their capacity by an action of the test operator, who was not aware of the consequences. The action consisted of shorting an internal ground (G_1, G_2, or G_3) to the frame of the SCC after the megohm test. (Refer to points A to B in fig. 17.) This action was taken by the test operator to avoid electrical shock from filter capacitors that had been charged to several hundred volts when the megohm test voltage was applied to the frame of a control assembly in the SCC. The control assemblies were insulated from the frame, and this insulation was tested each time by the megohm test unit. The test specification required that 500 V dc be applied across a test point on the control assembly to the SCC frame for 2 minutes, then the insulation resistance would be read. During this 2-minute period, the filter capacitors were charged through the multitude of relay, time-delay, and differentiator paths.

Laboratory tests of transistor Q_1, used in the time-delay circuits (fig. 17), were performed to determine the collector-to-base breakdown strength under pulse conditions. The test consisted of superimposing a positive pulse on a 28-V dc signal on the collector of transistor Q_1 in a time-delay circuit. The circuit was repeatedly pulsed, increasing amplitudes in 10-volt increments to 228 V dc (maximum pulse amplitude plus 28 V dc) or until failure, whichever occurred first. Fifty-six transistors were tested in the laboratory under these conditions, and 35 transistors failed. Each time a transistor failed, zener diode CR_1 was also overstressed and failed. The failed

transistor and zener diode had degraded or shorted junctions that were essentially the same as the failed parts in the SCC units of the MCP. During the laboratory test, the lowest pulse input to cause failure was at 108 V dc (28 V dc plus an 80-volt pulse). Six failures occurred at input signals of less than 150 V dc, 10 at less than 170, 20 at less than 198, and 35 at less than 228. Thirty of the transistors failed on the first voltage pulse at the failure level, five transistors failed by the fifth pulse. The 21 transistors that did not fail were ultimately pulsed 170 times at 228 V dc. After the cause of failure had been determined, it remained to be proved that the components that had not failed were not degraded by the megohm tests, even though they seemed to function satisfactorily. Three of the 21 transistors were selected at random and were pulsed for a minimum of 43 000 cycles without a failure. Therefore, the misapplication of the megohm test could cause immediate failures but would not cause the components to be degraded and susceptible to subsequent failure.

18. In February 1967, the insulation-resistance megohm test used during acceptance testing was determined to be the cause of the failures. After the megohm test was eliminated and a multimeter was used to check the insulation resistance, no more time-delay failures occurred.

On the basis of the vendor's successful isolation of the cause of the failures, its proper corrective action to prevent future occurrences, and its demonstration that existing time-delay transistors in the MCP were not degraded, the problem was closed on April 6, 1967.

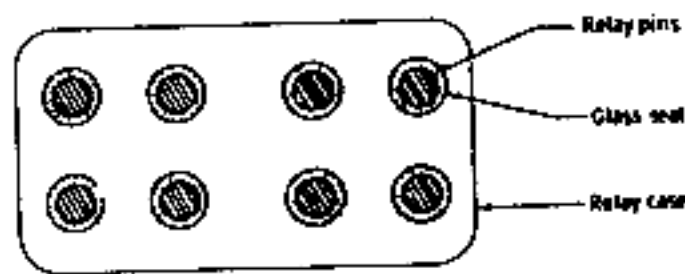
## Cracking of Glass Seals Caused by Clipping of Relay Pins

The problem involving cracked glass seals did not adversely affect a program or a spacecraft, because the only two failures occurred in qualification unit 1 during the postflight test of spacecraft 011. The specification required that all component leads that mount on printed circuit boards shall not protrude through the board more than 0.76 millimeter (0.030 inch). The relays, diodes, transistors, and other electrical components using glass-to-metal seals around their leads (or pins) were discovered to be subject to a shock wave during the process of clipping the pin. This shock wave was transferred down the pin and could possibly crack the glass seals. (The wire cutters, diagonal-cutting pliers, or side-cutting pliers use a wedge or chisel effect to separate the wire.) At the instant of final metal separation, rather severe forces (or shock waves) were transferred along the wire.

The problem with the MCP relays was a result of the vendor's fabrication techniques, which required the leads to be clipped. The relays, including the pin seals, were first inspected and then inserted in the circuit boards; the leads were clipped, the cut pins were soldered, and the solder was inspected. (At this time, the relay-pin seals could not be seen.) The clipping operation mechanically stressed the relay pins and cracked some of the glass seals.

Whenever a glass seal cracked or the relay pin became loose in the glass seal, the pin was free to rotate; merely the wrist action of the technician clipping the pin could rotate the pin and alter the critical relay contact alinement (fig. 18). The manufacturing alinement procedures required that the contacts first be set at a minimum 0.127-millimeter (0.005 inch) clearance. An overtravel adjustment was then checked and established at 0.0635 millimeter (0.0025 inch) to effect the proper wiping action of the relay contacts and then the proper electrical transfer. Alinement of the contacts had to be within ±3°. A projected viewgraph, which magnifies the contacts many times

(a) Bottom view of relay-case header.

(b) Top view of relay pins with contacts in open configuration.

their actual size, was used by the manufacturer to inspect and check these adjustments. Failure or improper action of the relays could occur for insufficient contact gaps or for contact gaps with too great a clearance. To prevent future problems, the vendor eliminated the relay clipping during the manufacturing process. An NASA Flight Safety Information Bulletin was published to notify all Apollo Program participants of the hazards of clipping terminals with glass-to-metal seals.
